P-Δ Behaviour of Three Dimensional Single-Storey Infilled R.C. Frame with SLAB

Abstract

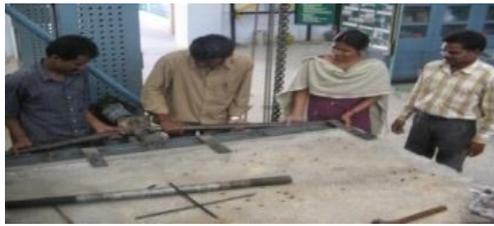
Fig .2: Fixing of loading frame

Loading arrangements: Lateral cyclic loading applied at storey level through the loading frame in line with the beams (Figure 2). The Jack operated by a hydraulic pump and the Jack controlled by a common console. Reaction frame, which used for loading arrangements, fixed to the test floor. Single acting hydraulic jack of capacity 300 kN in capacity used at the required level. Loads applied from the jack at the top storey level of the frame. A pressure gauge used to measure the applied load. Point load applied to the loading frame which converts the point load to line load in the frame. The hydraulic jack placed at one end and the LVDTs placed on the opposite side to read the displacements. One LVDT placed at the midpoint of slab bottom to read center point

deflection of the slab. Other three LVDTs placed at the infill bay alone and at the columns tops of C₁ and C₄.

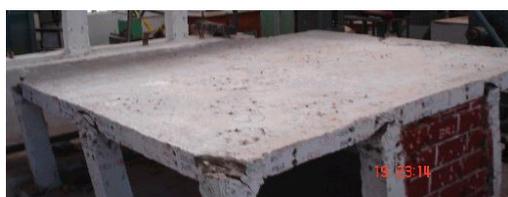
Fig. 9: RCC Slab in Three-Dimensional Frame

Behaviour of SLAB with Beams ON 3-D Frame: The presence of floor slab (Figure 9) with beams affects the behaviour of whole three-dimensional frame in two ways: One way, it increases the flexural capacity of beams and the other way, it imposes torsional moment on transverse beams that can affect the confinement of joints. The torsion induced in the transverse beams may cause them to crack and reduce their ability to confine the joint.
